## **Technical Service Bulletin**

Subject: Steering Gear Joint

Models Affected: Encore / Encore Max / SR5730: All Models, 114RS: All Models

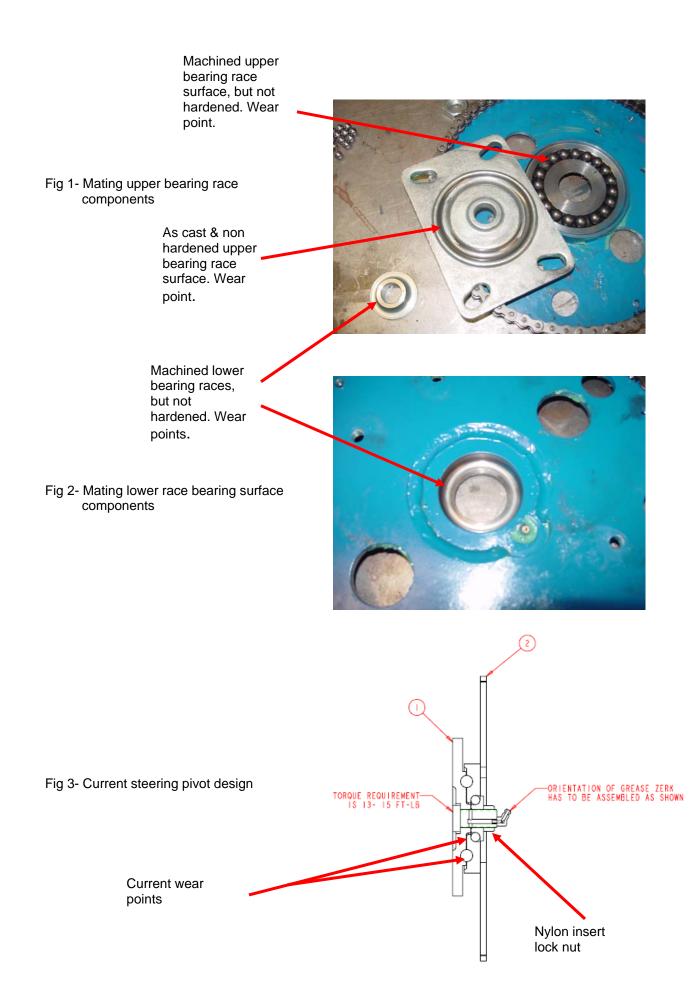
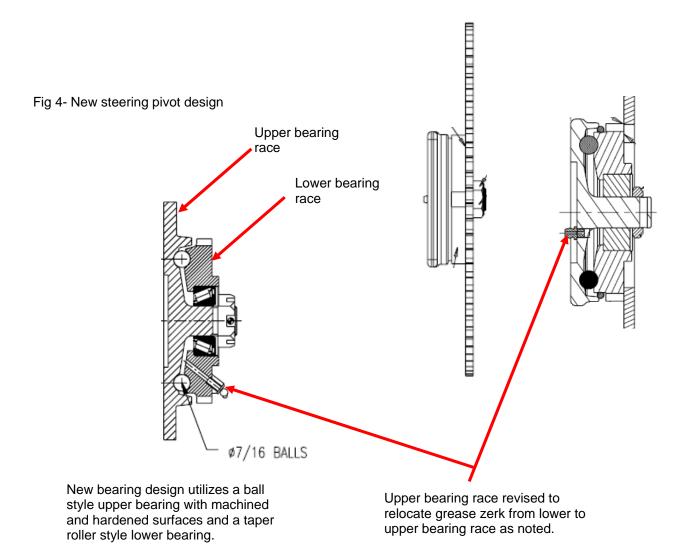
ISSUE: Machine drives roughly or has loose steering feel.

CAUSE: The steering pivot bearing joint loosens as the peaks in the as cast surface finish on the upper bearing race break down during joint break in. Joint loosening also results due to the wear of the bearing race. The wear can accelerate if the steering gear nut is not checked and retightened on a regular interval.

Replace steering pivot assembly, p/n's 7-57-05071 and 7-57-05071-1 with a new pivot assembly kit, p/n 56109178. The new kit consists of pivot assembly, p/n 56109177 and instruction sheet, p/n 56040907. The new pivot assembly utilizes machined and hardened bearing races and a castle nut.
